Feather River, RM 28.5R (LM 14.5, Sutter County LD 1 West)

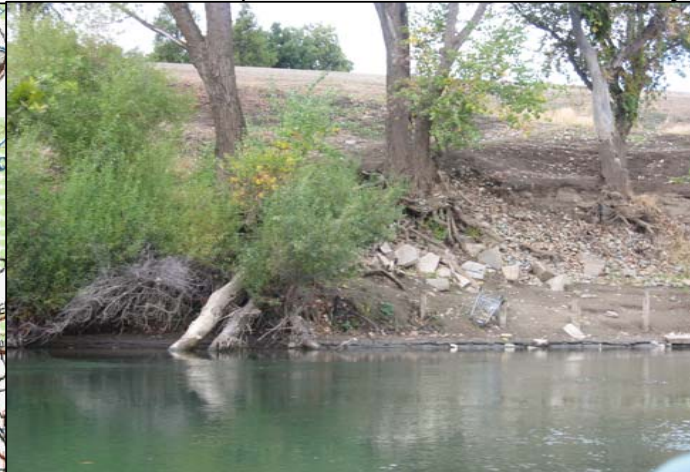
Site Photograph

Criteria	Score	Notes
Bank Slope (*2)	4	1:1 slope
Berm Width (*2) - Estimated	5	0 to 10 ft of berm
Location of erosion	4	toe and lower slope
Bank Stability	5	vertical sections, less than half bank height, and caves
Site Relative to Bend	1	relatively straight
Vegetation Cover	1	70% veg cover
Tree Hazard	5	large trees with exposed roots, some leaning
Soil Type (*2)	4	sands and silts
Velocity (*2)	3	4.03 ft/s
Human Usage	5	daily, paths and garbage
Erosion Hazard	53	Calculate Erosion Hazard

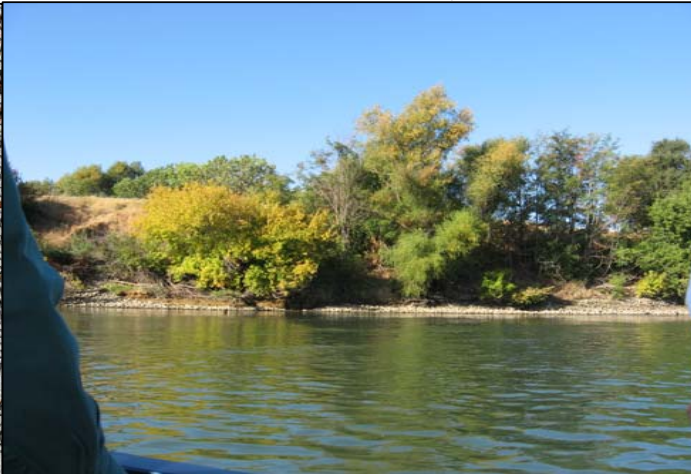
Site Photograph

Criteria	Score	Notes
Bank Slope (*2)	3	1.5:1 slope
Berm Width (*2) - Estimated	5	0 to 10 ft
Location of erosion	4	toe and lower bank
Bank Stability	5	vertical sections and caves
Site Relative to Bend	0	inside of a bend
Vegetation Cover	1	70%
Tree Hazard	5	large trees, exposed roots and leaning
Soil Type (*2)	4	sands and silts
Velocity (*2)	4	5.16 ft/s
Human Usage	4	weekly
Erosion Hazard	51	Calculate Erosion Hazard

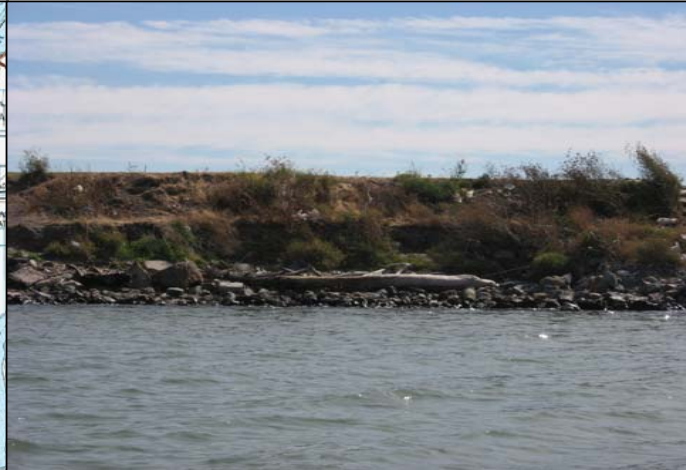
Site Photograph

Criteria	Score	Notes
Bank Slope (*2)	5	near vertical
Berm Width (*2) - Estimated	5	no berm
Location of erosion	2	levee slope
Bank Stability	4	vertical for more than half bank height
Site Relative to Bend	3	outside of a greater than 90 degree bend
Vegetation Cover	2	40 to 50 %
Tree Hazard	0	no trees
Soil Type (*2)	4	sands and silts
Velocity (*2)	4	5.13 ft/s
Human Usage	4	adjacent to road, weekly
Erosion Hazard	51	Calculate Erosion Hazard

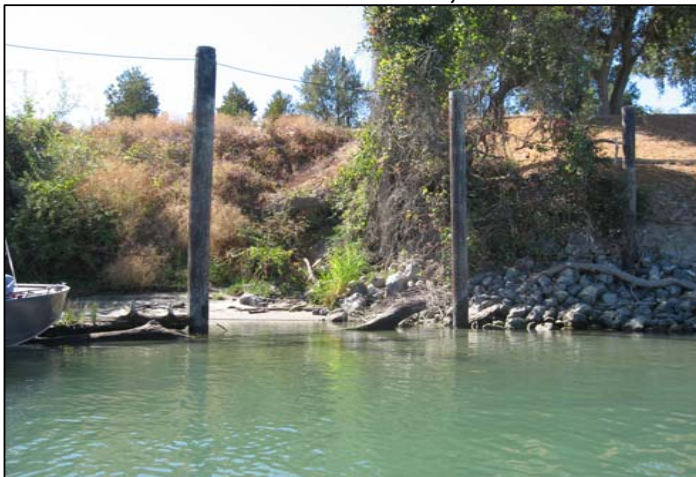
Site Photograph

Criteria	Score	Notes
Bank Slope (*2)	3	1.5:1 slope
Berm Width (*2) - Estimated	5	no berm
Location of erosion	4	toe and lower bank
Bank Stability	2	vertical sections, less than half bank height
Site Relative to Bend	1	straight
Vegetation Cover	1	60 to 70 %
Tree Hazard	5	large trees, exposed roots, and leaning
Soil Type (*2)	4	sands and silts
Velocity (*2)	4	5.36 ft/s
Human Usage	5	daily
Erosion Hazard	50	Calculate Erosion Hazard

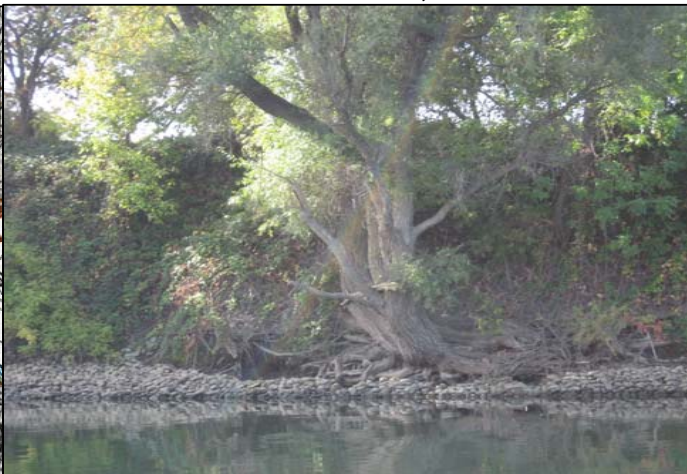
Site Photograph

Criteria	Score	Notes
Bank Slope (*2)	4	1:1 slope
Berm Width (*2) - Estimated	2	10 to 20 ft
Location of erosion	4	whole bank and toe
Bank Stability	5	caves greater than 4 ft and vertical sections
Site Relative to Bend	2	just downstream of a bend
Vegetation Cover	2	50 -60%
Tree Hazard	5	trees with exposed roots, some leaning
Soil Type (*2)	4	sands and silts
Velocity (*2)	3	3.39 ft/s
Human Usage	5	Debris and paths indicative of daily use
Erosion Hazard	49	Calculate Erosion Hazard

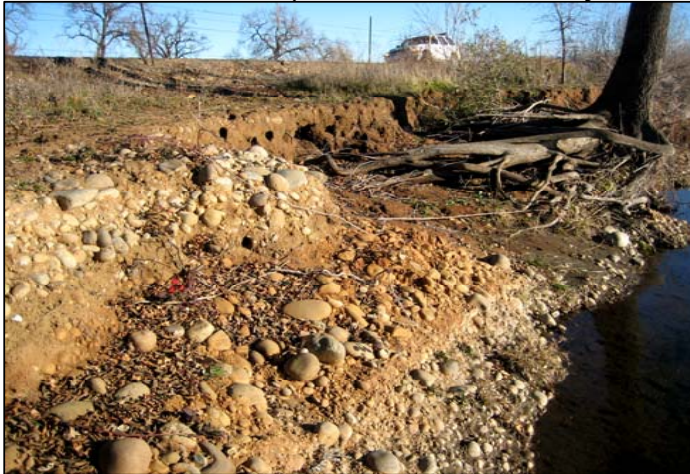
Site Photograph

Criteria	Score	Notes
Bank Slope (*2)	5	near vertical
Berm Width (*2) - Estimated	2	10 to 15 ft
Location of erosion	4	toe and bank
Bank Stability	5	Vertical sections, greater than half bank height and animal holes
Site Relative to Bend	3	outside of a gentle bend
Geomorph	0	tight levees, no migration expected
Vegetation Cover	4	minimal veg
Tree Hazard	5	large leaning trees with exposed roots
Soil Type (*2)	3	sands and cobbles
Velocity (*2)	4	~5+ ft/s
Human Usage	0	rare
Erosion Hazard	49	Calculate Erosion Hazard

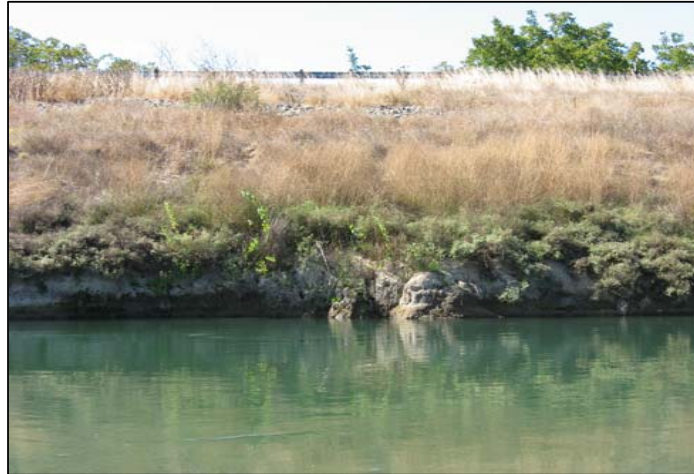
Site Photograph

Criteria	Score	Notes
Bank Slope (*2)	3	1.5:1 slope
Berm Width (*2) - Estimated	5	no berm
Location of erosion	4	upper bank and toe
Bank Stability	2	vertical sections, less than half bank height, 40 to 50 ft scour hole
Site Relative to Bend	5	outside of a less than 90 degree bend
Vegetation Cover	2	60%
Tree Hazard	2	2 medium trees
Soil Type (*2)	2	clays and silts
Velocity (*2)	4	5.27 ft/s
Human Usage	5	adjacent to road, next to a pump intake, daily use
Erosion Hazard	48	Calculate Erosion Hazard

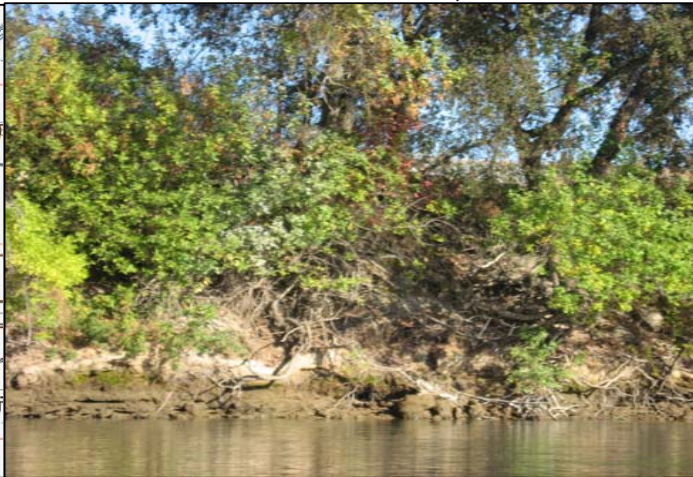
Site Photograph

Criteria	Score	Notes
Bank Slope (*2)	4	less than 1:1
Berm Width (*2) - Estimated	0	30 ft
Location of erosion	3	toe
Bank Stability	5	vertical sections greater than half bank height and animal holes
Site Relative to Bend	3	outside of a gentle bend
Vegetation Cover	4	less than 20%
Tree Hazard	5	exposed roots, trees leaning
Soil Type (*2)	4	sands and silts
Velocity (*2)	4	5.01 ft/s
Human Usage	4	weekly, paths and adjacent to road
Erosion Hazard	48	Calculate Erosion Hazard

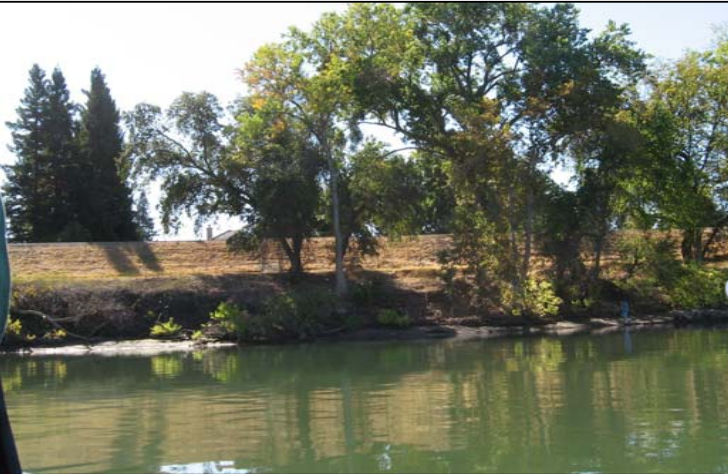
Site Photograph

Criteria	Score	Notes
Bank Slope (*2)	3	1.5:1
Berm Width (*2) - Estimated	3	5 to 10 ft
Location of erosion	4	toe, lower bank, and berm
Bank Stability	3	cave, greater than 4 ft
Site Relative to Bend	1	straight
Vegetation Cover	2	60%
Tree Hazard	5	trees with some exposed roots and leaning
Soil Type (*2)	4	sands and silts
Velocity (*2)	4	5.97 ft/s
Human Usage	5	daily
Erosion Hazard	48	Calculate Erosion Hazard

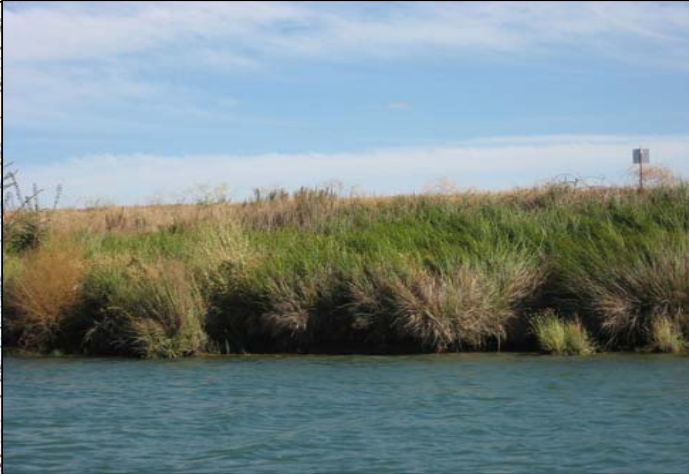
Site Photograph

Criteria	Score	Notes
Bank Slope (*2)	3	1.5:1 or less
Berm Width (*2) - Estimated	4	less than 5 ft
Location of erosion	5	levee slope, toe and underwater
Bank Stability	5	vertical sections and caves
Site Relative to Bend	3	outside of a gentle bend
Vegetation Cover	1	70% cover
Tree Hazard	4	large trees with exposed roots
Soil Type (*2)	4	sands and silts
Velocity (*2)	3	3.95 ft/s
Human Usage	2	seasonal
Erosion Hazard	48	Calculate Erosion Hazard

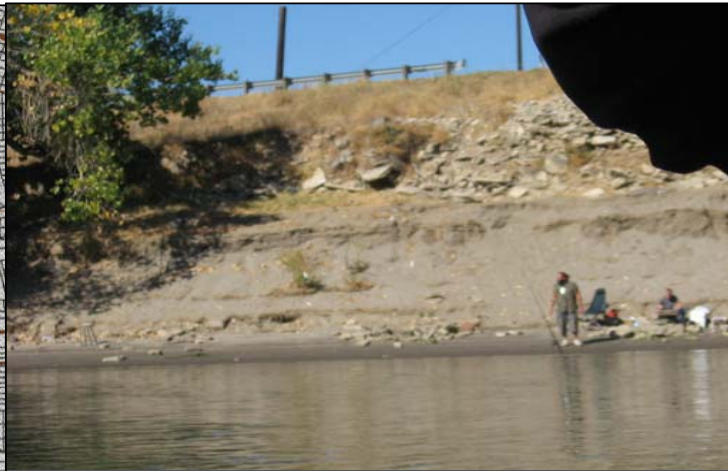
Site Photograph

Criteria	Score	Notes
Bank Slope (*2)	4	1:1 slope
Berm Width (*2) - Estimated	3	5 ft of berm
Location of erosion	4	whole bank and toe
Bank Stability	2	small vertical sections
Site Relative to Bend	0	inside of a bend
Vegetation Cover	2	50%
Tree Hazard	4	large trees with exposed roots
Soil Type (*2)	4	sand and silts
Velocity (*2)	4	6.02 ft/s
Human Usage	5	daily, parking area on levee, paths down, debris
Erosion Hazard	47	Calculate Erosion Hazard

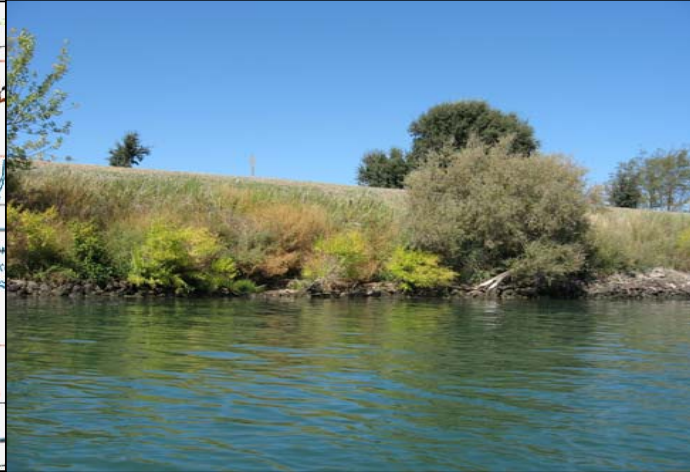
Site Photograph

Criteria	Score	Notes
Bank Slope (*2)	3	1.5:1 slope
Berm Width (*2) - Estimated	5	no berm
Location of erosion	4	toe
Bank Stability	5	vertical sections and caves
Site Relative to Bend	0	inside of a bend
Vegetation Cover	1	70%
Tree Hazard	1	young trees
Soil Type (*2)	4	sands and silts
Velocity (*2)	4	6.52 ft/s
Human Usage	4	weekly
Erosion Hazard	47	Calculate Erosion Hazard

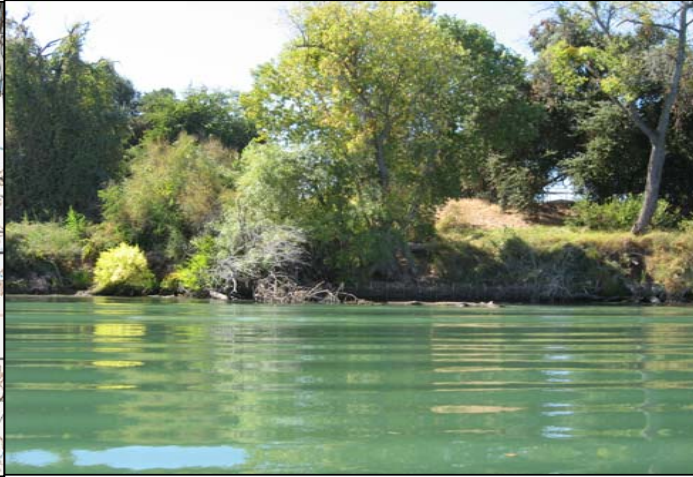
Site Photograph

Criteria	Score	Notes
Bank Slope (*2)	3	1.5:1 slope
Berm Width (*2) - Estimated	5	no berm
Location of erosion	2	lower bank
Bank Stability	1	caves from fallen trees
Site Relative to Bend	1	straight
Vegetation Cover	1	60 to 70%
Tree Hazard	5	large trees with exposed roots and leaning
Soil Type (*2)	4	sands and silts
Velocity (*2)	4	5.08 ft/s
Human Usage	4	adjacent to road, pathway down, weekly
Erosion Hazard	46	Calculate Erosion Hazard

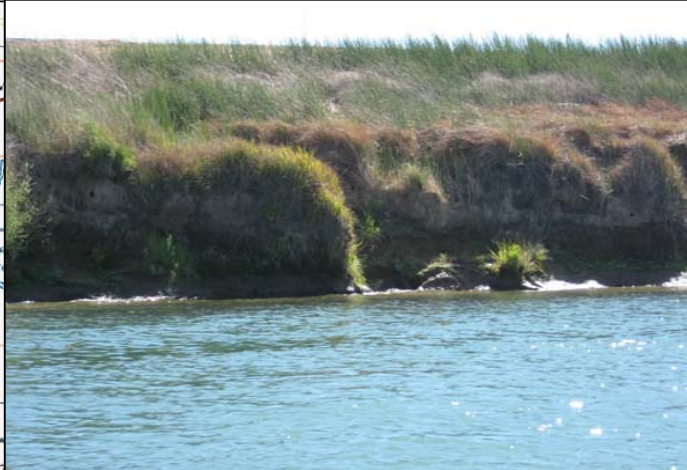
Site Photograph

Criteria	Score	Notes
Bank Slope (*2)	2	2:1 slope
Berm Width (*2) - Estimated	5	no berm
Location of erosion	5	toe and underwater
Bank Stability	4	vertical sections greater than half bank height
Site Relative to Bend	3	outside of a greater than 90 degree bend
Vegetation Cover	2	50%
Tree Hazard	1	lone small tree
Soil Type (*2)	4	sands and silts
Velocity (*2)	4	6.52 ft/s
Human Usage	1	steep sections, occasional usage
Erosion Hazard	46	Calculate Erosion Hazard

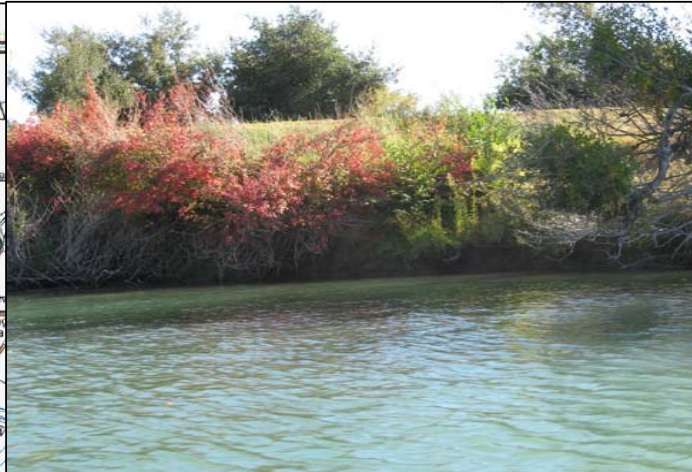
Site Photograph

Criteria	Score	Notes
Bank Slope (*2)	4	1:1 or less
Berm Width (*2) - Estimated	5	0 to 50 ft
Location of erosion	5	bank, toe, and underwater
Bank Stability	4	vertical sections, greater than half bank height
Site Relative to Bend	1	straight
Vegetation Cover	1	70 to 80%
Tree Hazard	4	trees with exposed roots
Soil Type (*2)	2	clays and silts
Velocity (*2)	4	5.13 ft/s
Human Usage	1	occassional
Erosion Hazard	46	Calculate Erosion Hazard

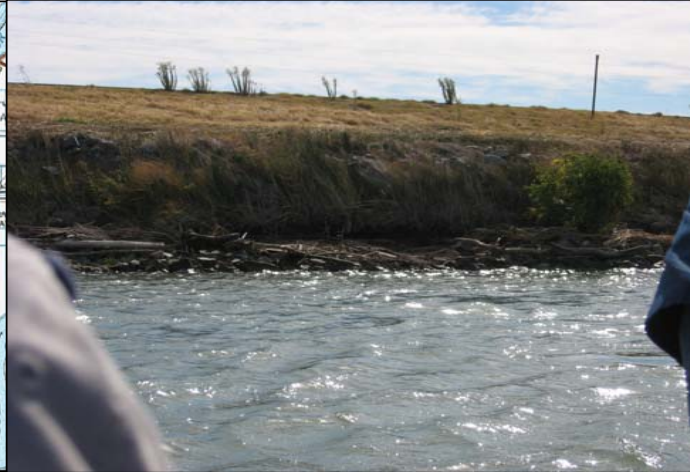
Site Photograph

Criteria	Score	Notes
Bank Slope (*2)	4	1:1 slope
Berm Width (*2) - Estimated	5	no berm
Location of erosion	1	mid bank
Bank Stability	2	vertical sections, less than half bank height
Site Relative to Bend	1	straight
Vegetation Cover	3	varies, 30 to 60 %
Tree Hazard	0	no trees
Soil Type (*2)	4	sands and silts
Velocity (*2)	4	7.05 ft/s
Human Usage	5	path and trash, daily
Erosion Hazard	46	Calculate Erosion Hazard

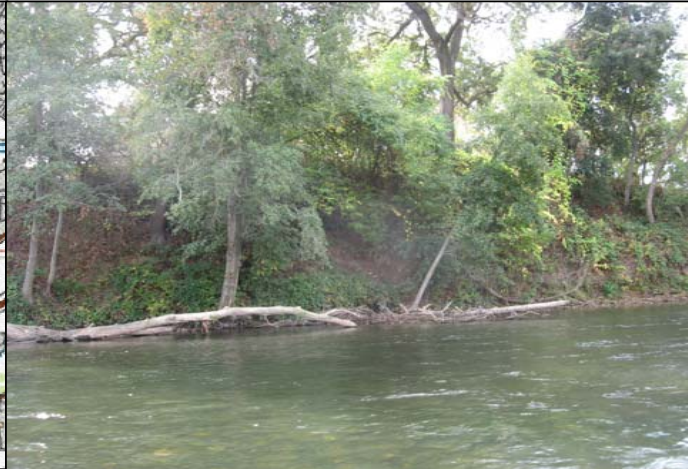
Site Photograph

Criteria	Score	Notes
Bank Slope (*2)	5	near vertical
Berm Width (*2) - Estimated	2	15 to 20 ft
Location of erosion	2	whole bank
Bank Stability	5	tree popouts and vertical sections
Site Relative to Bend	1	straight
Vegetation Cover	1	80%
Tree Hazard	5	large trees, exposed roots, and leaning
Soil Type (*2)	4	sands and silts
Velocity (*2)	3	3.94 ft/s
Human Usage	4	weekly, trails
Erosion Hazard	46	Calculate Erosion Hazard

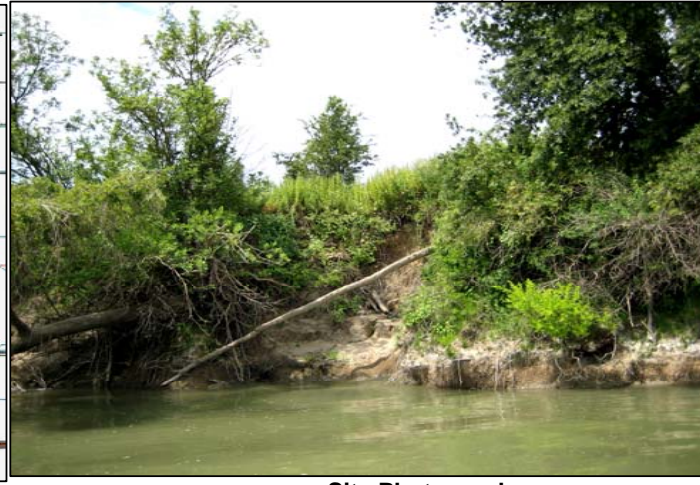
Site Photograph

Criteria	Score	Notes
Bank Slope (*2)	4	1:1 slope
Berm Width (*2) - Estimated	1	25 ft
Location of erosion	4	berm and toe
Bank Stability	5	vertical sections, greater than half bank height and animal burrows
Site Relative to Bend	1	straight
Vegetation Cover	2	50%
Tree Hazard	5	trees with exposed roots and leaning
Soil Type (*2)	4	sands and silts
Velocity (*2)	4	5.05 ft/s
Human Usage	2	seasonal
Erosion Hazard	45	Calculate Erosion Hazard

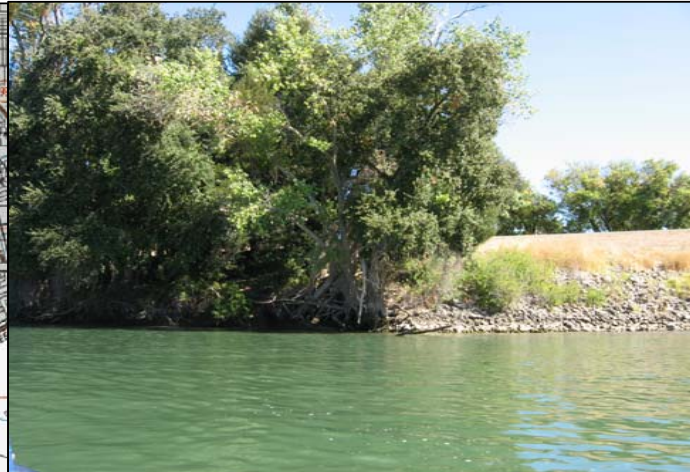
Site Photograph

Criteria	Score	Notes
Bank Slope (*2)	3	1.5:1 slope
Berm Width (*2) - Estimated	2	10 ft of berm
Location of erosion	5	bank, toe, and underwater
Bank Stability	2	some small vertical sections
Site Relative to Bend	1	straight
Vegetation Cover	1	60%
Tree Hazard	4	large trees with exposed roots
Soil Type (*2)	5	silts
Velocity (*2)	4	5.6 ft/s (UNET)
Human Usage	4	bike path on top, weekly
Erosion Hazard	45	Calculate Erosion Hazard

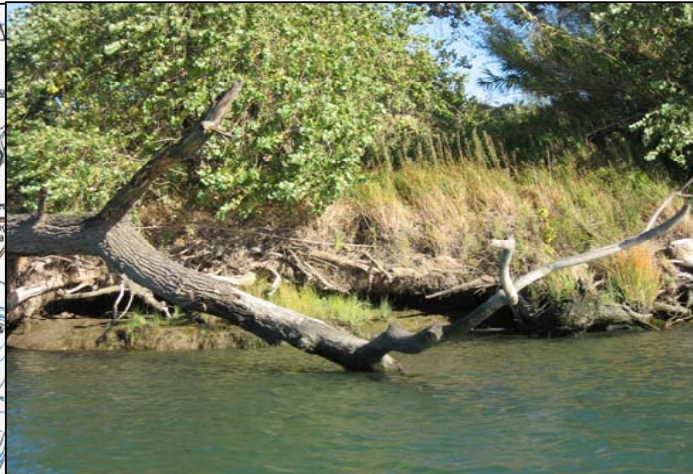
Site Photograph

Criteria	Score	Notes
Bank Slope (*2)	4	1:1 slope
Berm Width (*2) - Estimated	2	10 ft
Location of erosion	4	berm and toe
Bank Stability	5	caves, less than 4 ft, and vertical sections
Site Relative to Bend	1	straight
Vegetation Cover	0	90%
Tree Hazard	5	large leaning trees, exposed roots
Soil Type (*2)	4	sands and silts
Velocity (*2)	3	4.54 ft/s
Human Usage	4	weekly, path and picnic table
Erosion Hazard	45	Calculate Erosion Hazard

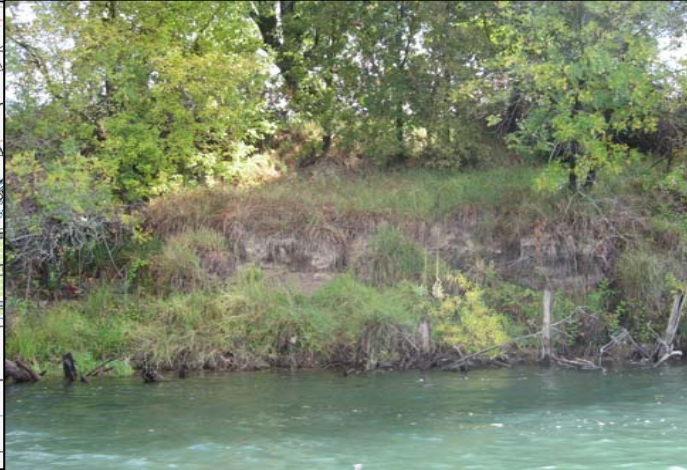
Site Photograph

Criteria	Score	Notes
Bank Slope (*2)	4	1:1 slope or less
Berm Width (*2) - Estimated	0	50 ft
Location of erosion	4	whole bank and toe
Bank Stability	5	caves, greater than 4 ft and vertical sections
Site Relative to Bend	3	outside of a greater than 90 degree bend
Vegetation Cover	3	40 to 50%
Tree Hazard	5	large trees with exposed roots and trees sliding down the bank
Soil Type (*2)	4	sands and silts
Velocity (*2)	4	5.34 ft/s
Human Usage	1	rather steep, not too accessible, occassional
Erosion Hazard	45	Calculate Erosion Hazard

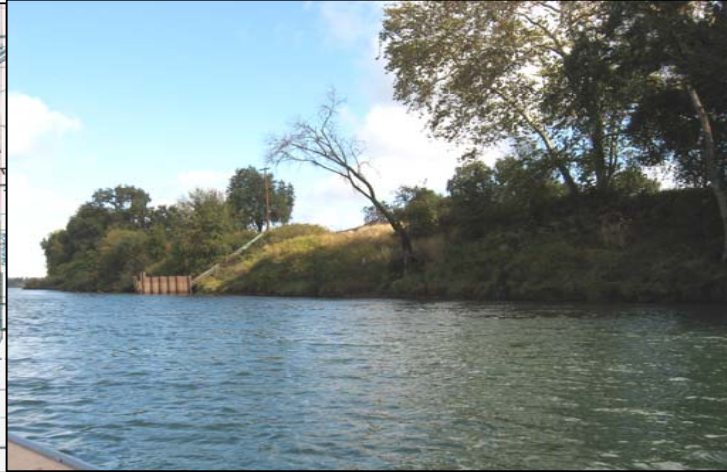
Site Photograph

Criteria	Score	Notes
Bank Slope (*2)	4	1:1 slope
Berm Width (*2) - Estimated	2	15 ft
Location of erosion	5	toe and underwater
Bank Stability	2	vertical sections, less than half bank slope height
Site Relative to Bend	1	straight
Vegetation Cover	0	dense on bank, about 80%
Tree Hazard	4	trees with visible roots
Soil Type (*2)	4	sands and silts
Velocity (*2)	4	5.46 ft/s
Human Usage	5	frequent, trails down to bank
Erosion Hazard	45	Calculate Erosion Hazard

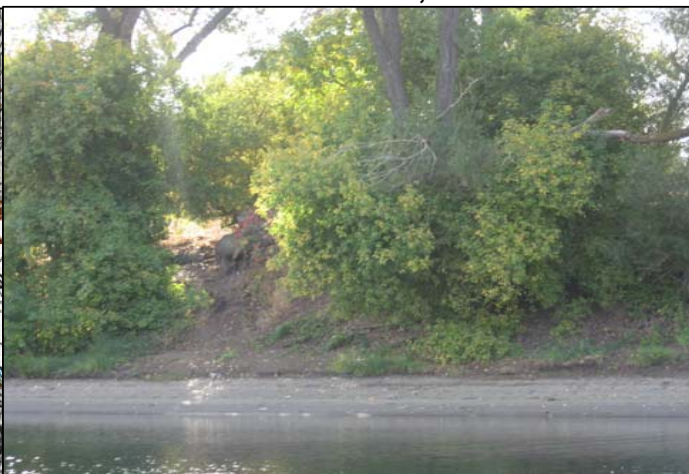
Site Photograph

Criteria	Score	Notes
Bank Slope (*2)	3	1.5:1 slope
Berm Width (*2) - Estimated	3	6 to 30 ft
Location of erosion	4	bank and toe
Bank Stability	0	no stability issues
Site Relative to Bend	0	inside of a slight bend
Vegetation Cover	3	about 40 %
Tree Hazard	5	large trees with exposed roots, some leaning
Soil Type (*2)	4	sands and silts
Velocity (*2)	4	5.2 ft/s
Human Usage	5	Bike path on top of levee, trails down, trash present, daily use
Erosion Hazard	45	Calculate Erosion Hazard

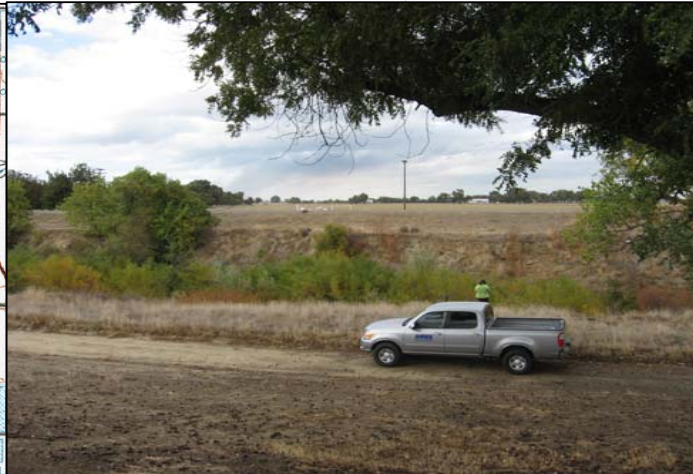
Site Photograph

Criteria	Score	Notes
Bank Slope (*2)	4	less than 1:1
Berm Width (*2) - Estimated	2	10 to 25 ft
Location of erosion	4	whole bank and toe
Bank Stability	5	vertical sections and caves
Site Relative to Bend	1	straight
Vegetation Cover	3	30%
Tree Hazard	4	large trees with exposed roots
Soil Type (*2)	4	sands and silts
Velocity (*2)	4	6 ft/s
Human Usage	0	rare
Erosion Hazard	45	Calculate Erosion Hazard

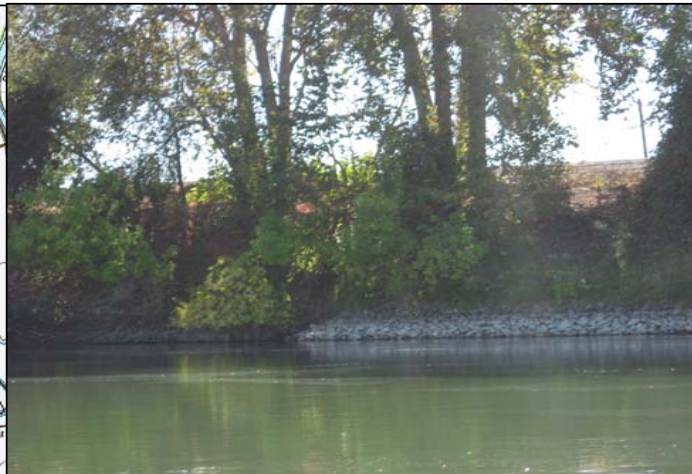
Site Photograph

Criteria	Score	Notes
Bank Slope (*2)	4	1.5:1 slope
Berm Width (*2) - Estimated	1	25 30 ft
Location of erosion	5	toe and underwater
Bank Stability	2	vertical sections, less than half bank height
Site Relative to Bend	1	straight
Vegetation Cover	3	30%
Tree Hazard	5	large trees, roots exposed and leaning
Soil Type (*2)	4	sands and silts
Velocity (*2)	3	3.18 ft/s
Human Usage	4	weekly, trail to bank
Erosion Hazard	44	Calculate Erosion Hazard

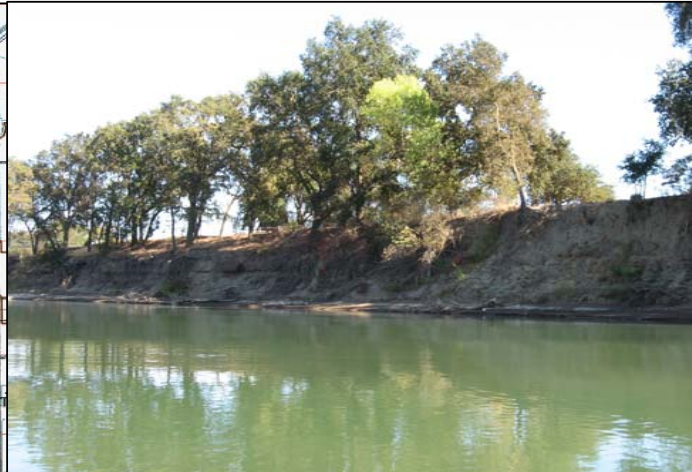
Site Photograph

Criteria	Score	Notes
Bank Slope (*2)	5	vertical bank
Berm Width (*2) - Estimated	0	40 to 50 ft
Location of erosion	3	full bank
Bank Stability	5	beaver burrows and vertical bank
Site Relative to Bend	2	just downstream of a bend
Vegetation Cover	4	10%
Tree Hazard	5	large trees with exposed roots and leaning
Soil Type (*2)	4	sands and silts
Velocity (*2)	2	2.15 ft/s
Human Usage	3	monthly, trail but not easy to access
Erosion Hazard	44	Calculate Erosion Hazard

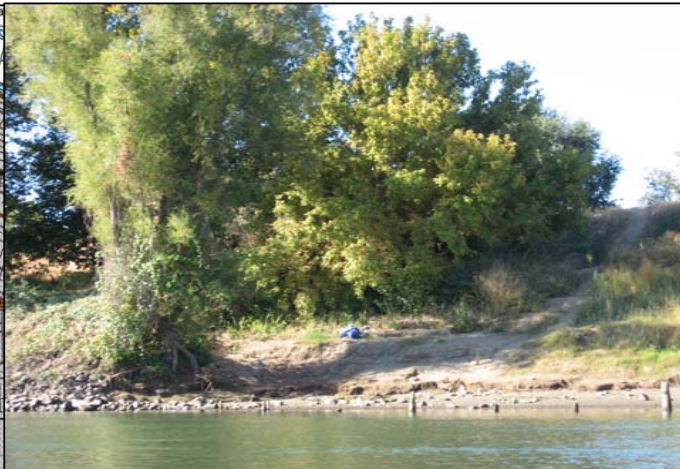
Site Photograph

Criteria	Score	Notes
Bank Slope (*2)	2	2:1 slope
Berm Width (*2) - Estimated	5	0 to 10 ft
Location of erosion	3	toe
Bank Stability	0	no vertical sections or caves
Site Relative to Bend	1	straight
Vegetation Cover	1	70%
Tree Hazard	4	large trees with exposed roots
Soil Type (*2)	4	sands and silts
Velocity (*2)	4	5.02 ft/s
Human Usage	5	daily
Erosion Hazard	44	Calculate Erosion Hazard

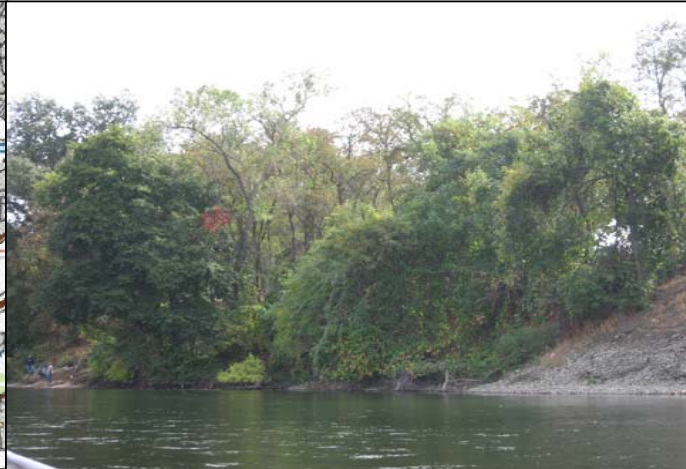
Site Photograph

Criteria	Score	Notes
Bank Slope (*2)	3	1.5:1 slope
Berm Width (*2) - Estimated	2	10 to 15 ft
Location of erosion	2	lower bank
Bank Stability	2	vertical sections, less than half bank height
Site Relative to Bend	1	straight
Vegetation Cover	1	60%
Tree Hazard	5	large trees, some exposed roots, some leaning
Soil Type (*2)	4	sands and silts
Velocity (*2)	5	8.74 ft/s
Human Usage	5	daily, people on banks, lots of trash and paths
Erosion Hazard	44	Calculate Erosion Hazard

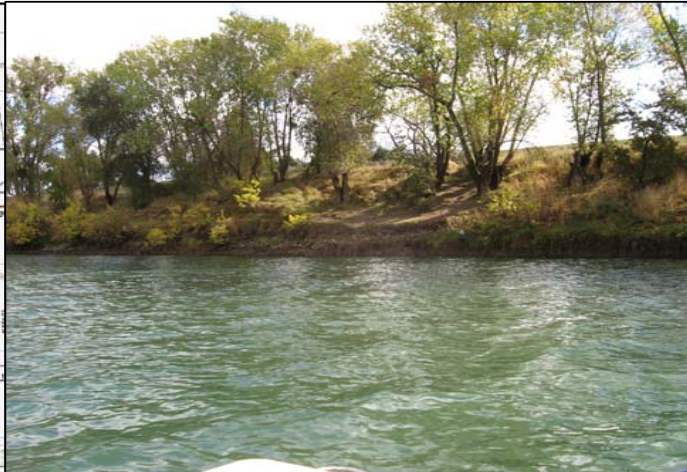
Site Photograph

Criteria	Score	Notes
Bank Slope (*2)	1	2.5:1 on bank
Berm Width (*2) - Estimated	3	about 5 ft
Location of erosion	3	toe
Bank Stability	2	vertical sections, less than half bank slope
Site Relative to Bend	3	outside of a greater than 90 degree bend
Vegetation Cover	2	40 to 50 %
Tree Hazard	3	large trees
Soil Type (*2)	4	sands and silts with cobbles underneath
Velocity (*2)	5	9.97 ft/s
Human Usage	5	multiple paths down the bank and trash
Erosion Hazard	44	Calculate Erosion Hazard

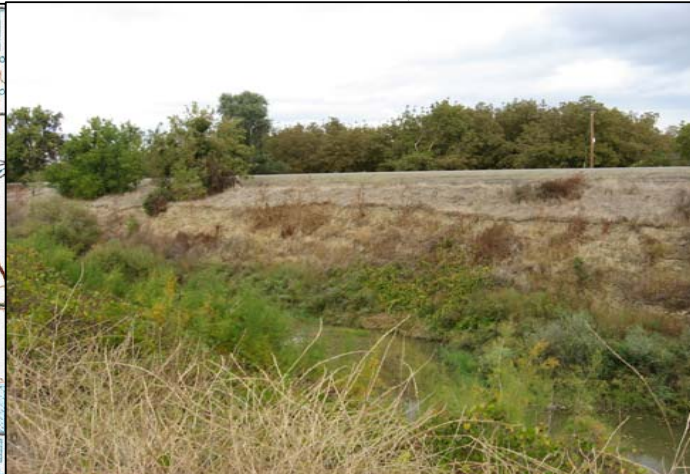
Site Photograph

Criteria	Score	Notes
Bank Slope (*2)	4	1:1 slope
Berm Width (*2) - Estimated	2	15 to 30 feet
Location of erosion	4	toe and upper bank
Bank Stability	5	vertical sections, less than half slope height, and caves
Site Relative to Bend	5	outside of a less than 90 degree bend
Vegetation Cover	2	40%
Tree Hazard	0	no trees
Soil Type (*2)	4	sands and silts
Velocity (*2)	4	6.5 ft/s
Human Usage	0	adjacent to private property, rare usage
Erosion Hazard	44	Calculate Erosion Hazard

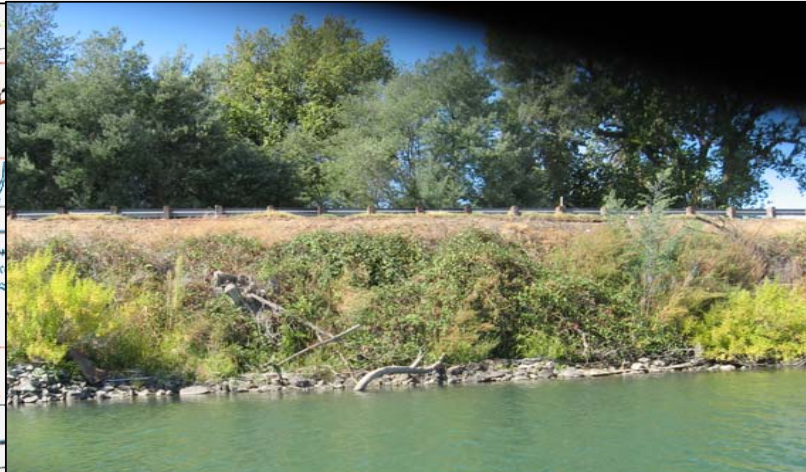
Site Photograph

Criteria	Score	Notes
Bank Slope (*2)	3	1.5:1 slope
Berm Width (*2) - Estimated	5	no berm
Location of erosion	2	full bnak
Bank Stability	0	no vertical sections or caves
Site Relative to Bend	3	outside of a greater than 90 degree bend
Vegetation Cover	1	60%
Tree Hazard	0	no trees
Soil Type (*2)	4	sands and silts
Velocity (*2)	4	5.89 ft/s
Human Usage	5	daily
Erosion Hazard	43	Calculate Erosion Hazard

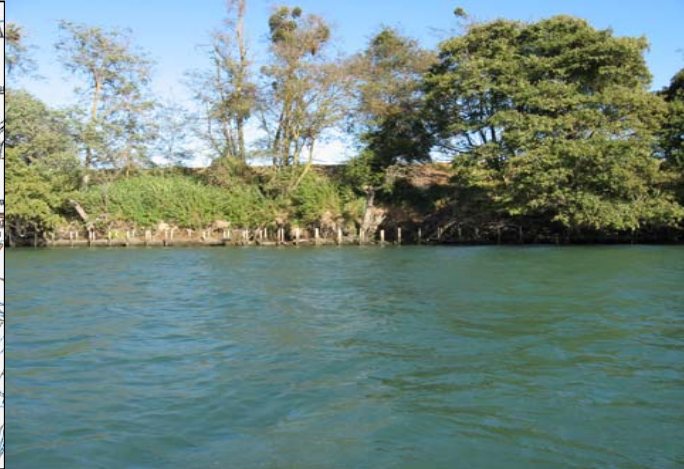
Site Photograph

Criteria	Score	Notes
Bank Slope (*2)	4	1:1 slope
Berm Width (*2) - Estimated	2	10 ft
Location of erosion	2	berm
Bank Stability	5	short vertical sections and caves
Site Relative to Bend	1	straight
Vegetation Cover	1	60 to 70 %
Tree Hazard	4	medium trees, exposed roots
Soil Type (*2)	4	sands and silts
Velocity (*2)	3	4.16 ft/s
Human Usage	4	weekly, path down
Erosion Hazard	43	Calculate Erosion Hazard

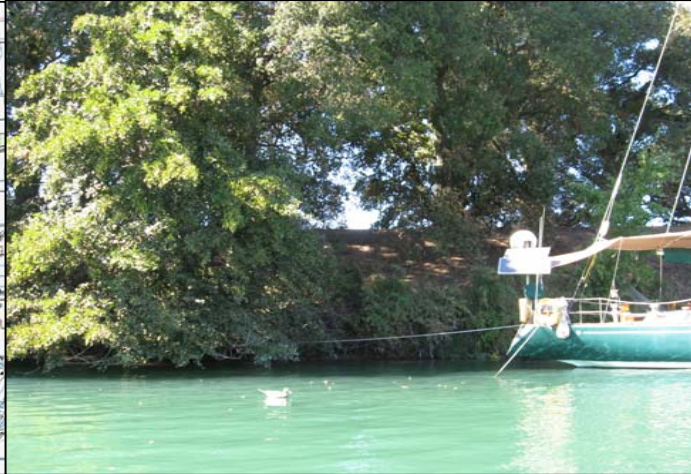
Site Photograph

Criteria	Score	Notes
Bank Slope (*2)	3	1.5:1 slope
Berm Width (*2) - Estimated	5	no berm
Location of erosion	4	toe and lower bank
Bank Stability	2	vertical sections
Site Relative to Bend	3	outside of slight bend
Vegetation Cover	1	60 - 70%
Tree Hazard	4	large trees, exposed roots
Soil Type (*2)	2	clays and silts
Velocity (*2)	3	4.87 ft/s
Human Usage	3	monthly
Erosion Hazard	43	Calculate Erosion Hazard

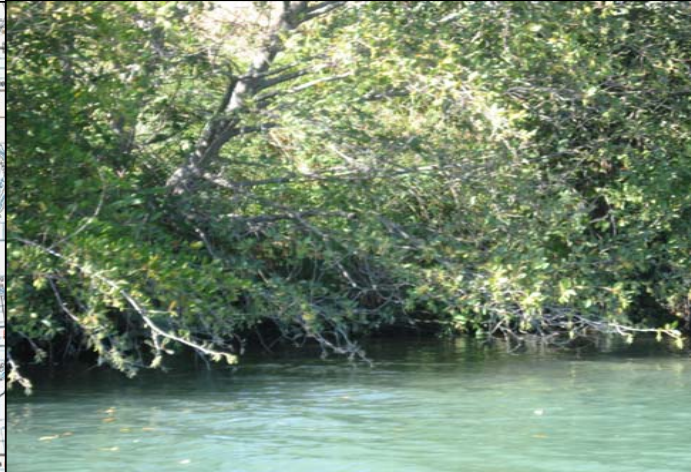
Site Photograph

Criteria	Score	Notes
Bank Slope (*2)	4	1:1 or less
Berm Width (*2) - Estimated	3	5 ft
Location of erosion	4	toe and bank
Bank Stability	2	vertical sections, less than half bank height
Site Relative to Bend	1	straight
Vegetation Cover	2	60%
Tree Hazard	4	large trees, exposed roots
Soil Type (*2)	4	sands and silts
Velocity (*2)	3	3.88 ft/s
Human Usage	2	seasonal
Erosion Hazard	43	Calculate Erosion Hazard

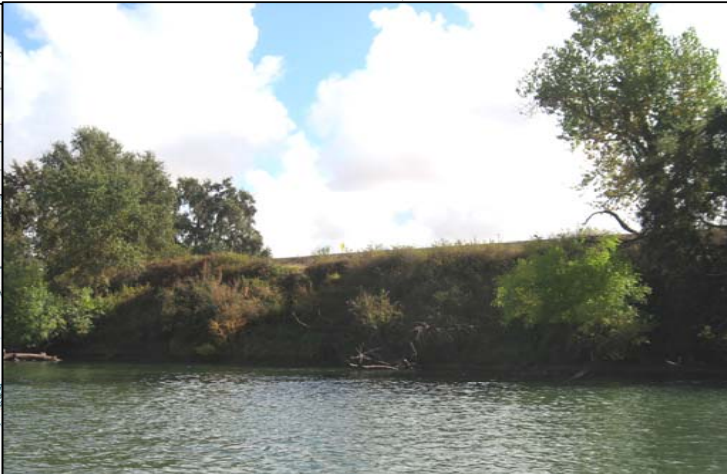
Site Photograph

Criteria	Score	Notes
Bank Slope (*2)	4	1:1 slope
Berm Width (*2) - Estimated	1	25 to 30 ft
Location of erosion	3	whole bank
Bank Stability	3	some holes from trees falling
Site Relative to Bend	1	straight
Vegetation Cover	1	70 to 80%
Tree Hazard	5	large trees with visible roots, some leaning
Soil Type (*2)	4	sands and silts
Velocity (*2)	4	7.08 ft/s
Human Usage	4	adjacent to road, weekly use
Erosion Hazard	43	Calculate Erosion Hazard

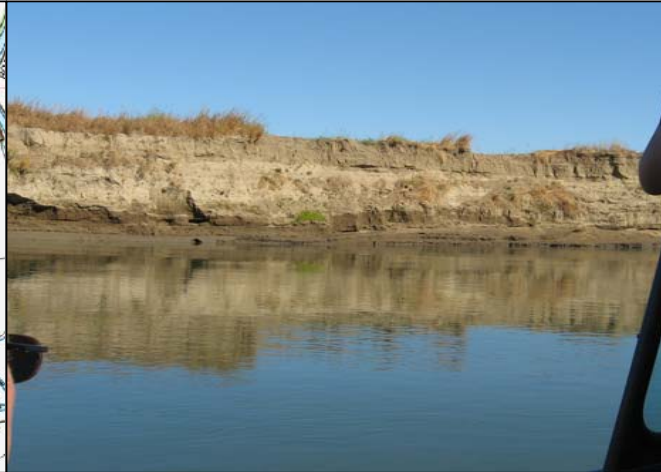
Site Photograph

Criteria	Score	Notes
Bank Slope (*2)	5	near vertical
Berm Width (*2) - Estimated	0	40 to 50 ft
Location of erosion	4	full bank and toe
Bank Stability	5	vertical sections greater than half bank height, and animal holes
Site Relative to Bend	0	inside of a bend
Vegetation Cover	4	10%
Tree Hazard	4	trees with exposed roots, one freshly fallen
Soil Type (*2)	4	sands and silts
Velocity (*2)	3	3.18 ft/s
Human Usage	1	occassional
Erosion Hazard	42	Calculate Erosion Hazard

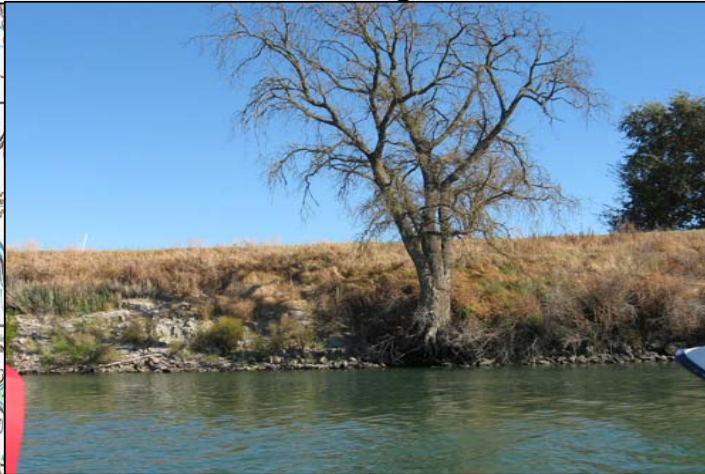
Site Photograph

Criteria	Score	Notes
Bank Slope (*2)	3	1.5:1 slope
Berm Width (*2) - Estimated	5	no berm
Location of erosion	3	toe
Bank Stability	0	no vertical sections or caves
Site Relative to Bend	1	straight
Vegetation Cover	2	50%
Tree Hazard	5	leaning trees with exposed roots
Soil Type (*2)	2	clays and silts
Velocity (*2)	4	5.62 ft/s
Human Usage	3	monthly
Erosion Hazard	42	Calculate Erosion Hazard

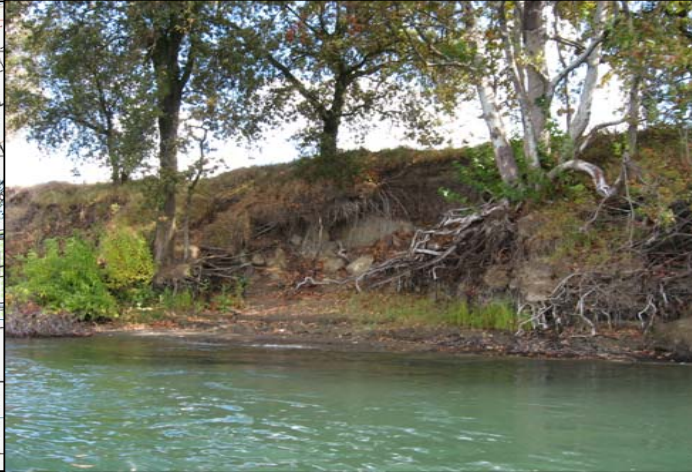
Site Photograph

Criteria	Score	Notes
Bank Slope (*2)	4	1:1 slope
Berm Width (*2) - Estimated	0	50 ft
Location of erosion	3	whole bank
Bank Stability	4	vertical sections for whole bank height
Site Relative to Bend	5	outside of a slightly less than 90 degree bend
Vegetation Cover	2	about 40 to 50%
Tree Hazard	5	large trees, roots exposed, and leaning
Soil Type (*2)	4	sands and silts
Velocity (*2)	3	4.63 ft/s
Human Usage	1	Dumping spot but not much usage
Erosion Hazard	42	Calculate Erosion Hazard

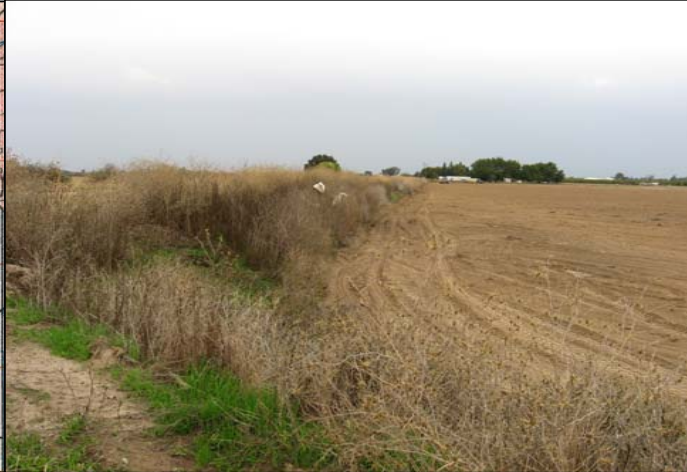
Site Photograph

Criteria	Score	Notes
Bank Slope (*2)	5	near vertical
Berm Width (*2) - Estimated	5	no berm
Location of erosion	4	toe and lower slope
Bank Stability	2	shallow vertical sections
Site Relative to Bend	1	straight
Vegetation Cover	4	minimal
Tree Hazard	0	no trees
Soil Type (*2)	4	sands and silts
Velocity (*2)	0	water does not reach the bank
Human Usage	3	monthly usage
Erosion Hazard	42	Calculate Erosion Hazard

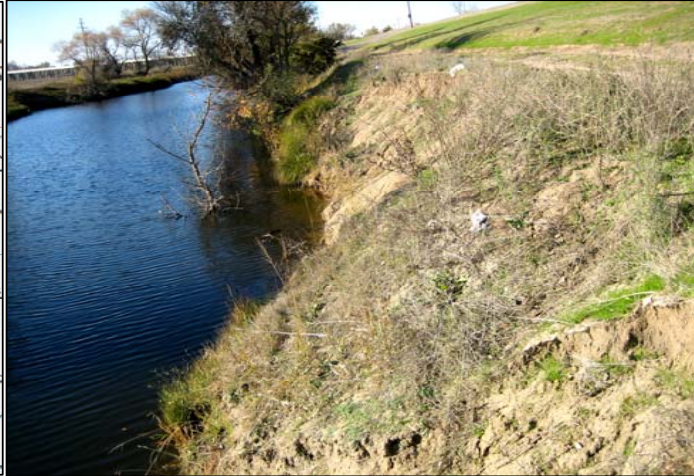
Site Photograph

Criteria	Score	Notes
Bank Slope (*2)	4	1:1 slope
Berm Width (*2) - Estimated	3	5 to 6 ft of berm
Location of erosion	4	toe and lower slope
Bank Stability	2	some vertical sections, less than half bank height
Site Relative to Bend	1	relatively straight
Vegetation Cover	3	minimal, less than 40%
Tree Hazard	2	medium sized trees
Soil Type (*2)	4	sands and silts
Velocity (*2)	2	3.0 ft/s
Human Usage	4	near road, trash evident, weekly
Erosion Hazard	42	Calculate Erosion Hazard

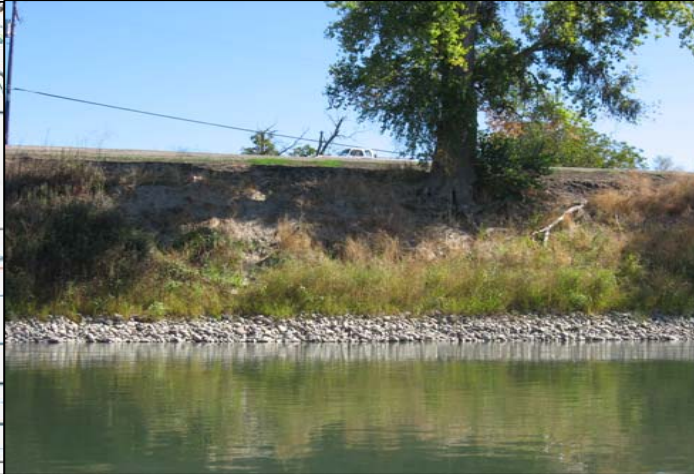
Site Photograph

Criteria	Score	Notes
Bank Slope (*2)	3	1.5:1 slope
Berm Width (*2) - Estimated	5	0 to 60 ft
Location of erosion	4	berm slope and toe
Bank Stability	0	no vertical sections or caves
Site Relative to Bend	5	outside of a tight bend
Vegetation Cover	2	50%
Tree Hazard	4	large trees with exposed roots
Soil Type (*2)	2	clays and silts
Velocity (*2)	2	2.86 ft/s
Human Usage	2	seasonal
Erosion Hazard	41	Calculate Erosion Hazard

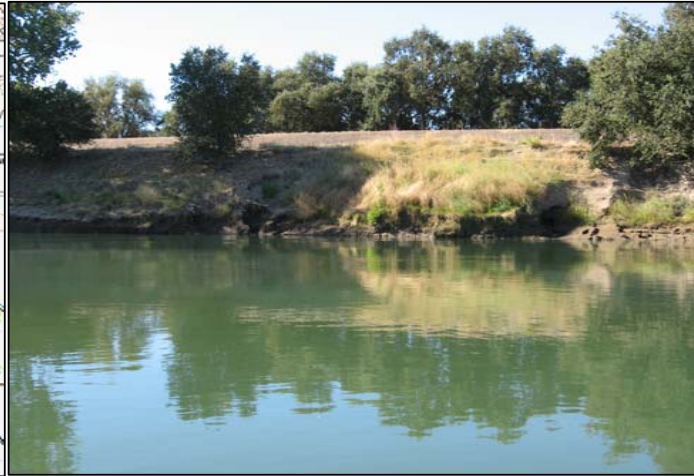
Site Photograph

Criteria	Score	Notes
Bank Slope (*2)	3	1.5:1 slope
Berm Width (*2) - Estimated	0	30 ft
Location of erosion	4	bank and toe
Bank Stability	5	vertical sections , greater than half bank height and caves
Site Relative to Bend	2	just downstream from a bend
Vegetation Cover	4	20%
Tree Hazard	5	trees with exposed roots and leaning
Soil Type (*2)	2	clays and silts
Velocity (*2)	4	5.17 ft/s
Human Usage	3	monthly
Erosion Hazard	41	Calculate Erosion Hazard

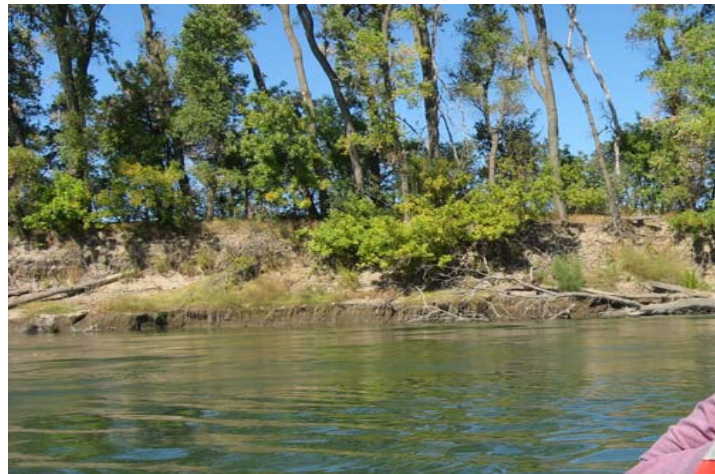
Site Photograph

Criteria	Score	Notes
Bank Slope (*2)	4	1:1 slope
Berm Width (*2) - Estimated	0	30 ft
Location of erosion	4	bank and toe
Bank Stability	4	vertical sections, greater than half bank height
Site Relative to Bend	1	straight
Vegetation Cover	4	10%
Tree Hazard	5	large trees with exposed roots, some leaning
Soil Type (*2)	4	sands and silts
Velocity (*2)	3	4.3 ft/s
Human Usage	1	occassional
Erosion Hazard	41	Calculate Erosion Hazard

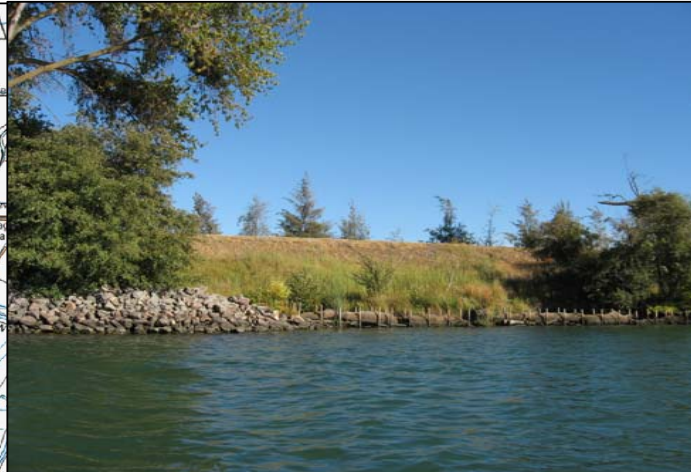
Site Photograph

Criteria	Score	Notes
Bank Slope (*2)	3	1.5:1 slope
Berm Width (*2) - Estimated	5	no berm
Location of erosion	2	berm
Bank Stability	4	vertical sections greater than half bank height
Site Relative to Bend	1	straight
Vegetation Cover	0	90%
Tree Hazard	3	large trees, one already fallen
Soil Type (*2)	4	sands and silts
Velocity (*2)	3	4.82 ft/s
Human Usage	1	occassional
Erosion Hazard	41	Calculate Erosion Hazard

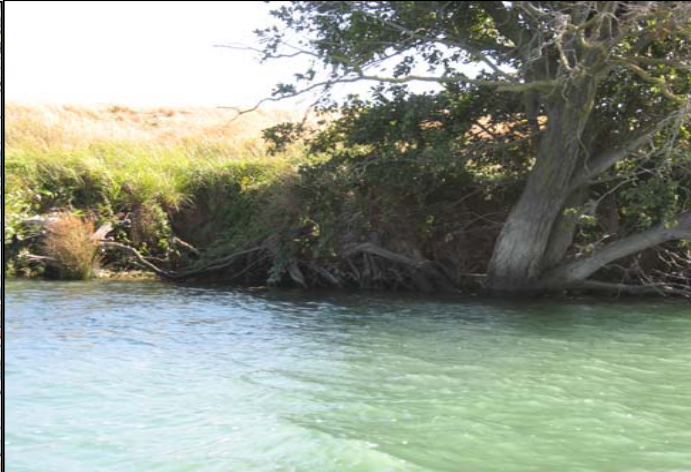
Site Photograph

Criteria	Score	Notes
Bank Slope (*2)	4	1:1 slope
Berm Width (*2) - Estimated	2	10 ft
Location of erosion	2	lower bank
Bank Stability	5	caves greater than 4 ft and vertical sections
Site Relative to Bend	1	straight
Vegetation Cover	4	70%
Tree Hazard	1	young trees
Soil Type (*2)	4	sands and silts
Velocity (*2)	3	3.77 ft/s
Human Usage	2	seasonal
Erosion Hazard	41	Calculate Erosion Hazard

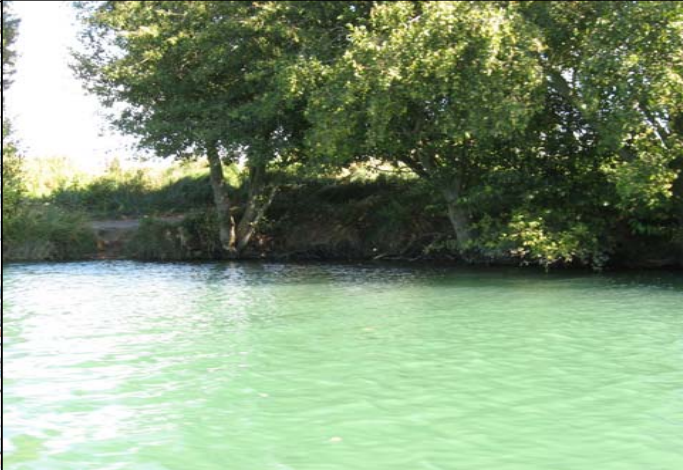
Site Photograph

Criteria	Score	Notes
Bank Slope (*2)	3	1.5:1 slope
Berm Width (*2) - Estimated	4	less than 5 ft
Location of erosion	3	toe
Bank Stability	4	cvertical sections
Site Relative to Bend	1	straight
Vegetation Cover	0	85%
Tree Hazard	5	trees with exposed roots and leaning
Soil Type (*2)	4	sands and silts
Velocity (*2)	3	3.94 ft/s
Human Usage	0	too steep for access
Erosion Hazard	41	Calculate Erosion Hazard

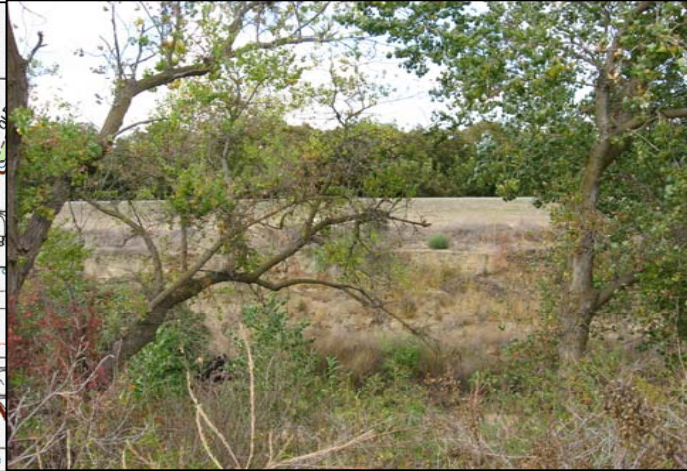
Site Photograph

Criteria	Score	Notes
Bank Slope (*2)	4	1:1 or less
Berm Width (*2) - Estimated	2	15 to 30 ft
Location of erosion	4	toe and upper bank slope
Bank Stability	4	vertical sections greater than half slope height
Site Relative to Bend	3	outside of gentle bend
Vegetation Cover	2	about 50%
Tree Hazard	0	no trees
Soil Type (*2)	4	sands and silts
Velocity (*2)	4	5.98 ft/s
Human Usage	0	private property adjacent, rare usage
Erosion Hazard	41	Calculate Erosion Hazard

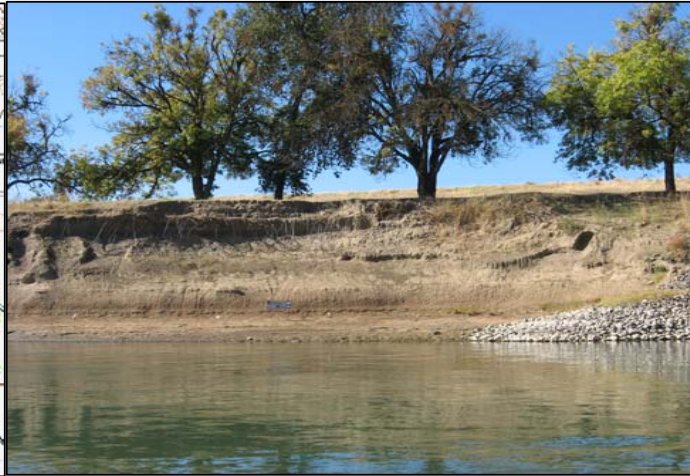
Site Photograph

Criteria	Score	Notes
Bank Slope (*2)	4	1:1 slope
Berm Width (*2) - Estimated	0	30 ft
Location of erosion	4	whole bank and toe
Bank Stability	5	vertical sections less than half bank height and caves
Site Relative to Bend	2	just downstream from a bend
Vegetation Cover	4	20%
Tree Hazard	4	large trees with exposed roots
Soil Type (*2)	2	clays and silts
Velocity (*2)	3	4.66 ft/s
Human Usage	3	monthly
Erosion Hazard	40	Calculate Erosion Hazard

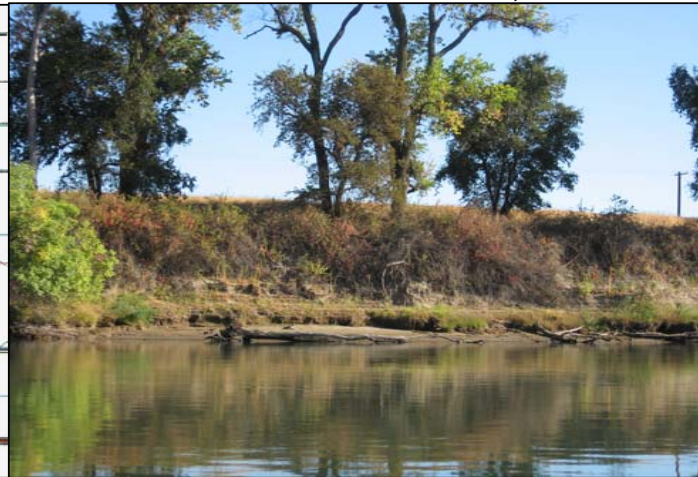
Site Photograph

Criteria	Score	Notes
Bank Slope (*2)	4	1:1 slope
Berm Width (*2) - Estimated	0	30 to 50 ft
Location of erosion	2	full bank
Bank Stability	5	vertical sections, greater than half bank height and caves
Site Relative to Bend	1	straight
Vegetation Cover	3	30%
Tree Hazard	3	large trees
Soil Type (*2)	2	clays and silts
Velocity (*2)	3	4.74 ft/s
Human Usage	4	weekly
Erosion Hazard	36	Calculate Erosion Hazard
